**Flood Control Project Maintenance  
Levee Inspections**

**Fall 2014 Levee Maintenance Deficiency Summary Report**

**Levee District No. 0001 (Glenn County)**

**Levee Inspection Report By Mile - Fall 2014**

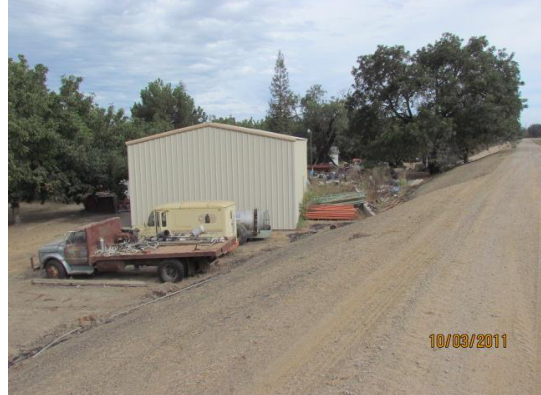
Photo 1 of 1 : FA\_2014\_LD0001G\_432\_4\_20141013\_00002.jpg

LM Start	1.10	Rating **	M	Issue No.	4
LM End	1.33	Issue Type +	En	Location *	LS
Category	Earthen Levee			GPS Latitude/Longitude	
				Start	End
Item	Encroachments			39.491887 °	39.494572 °
				-122.020238 °	-122.017840 °
DWR ID	DWR_LD0001G_01_s _ 2012_4				
Action/Comments					
Building

View of vehicles & equipment along the L/S toe.

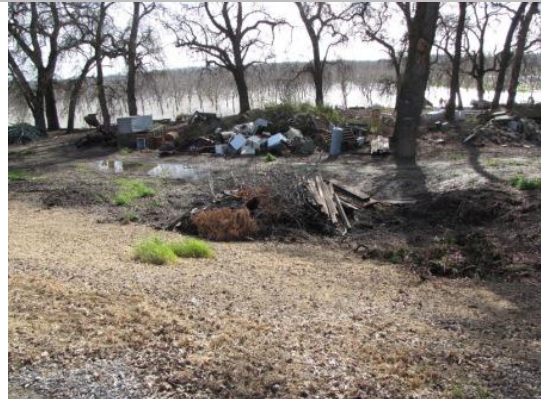
Photo 1 of 1 : FA\_2014\_LD0001G\_432\_1\_20141013\_00001.jpg

LM Start	1.23	Rating **	M	Issue No.	1
LM End	1.23	Issue Type +	Ma	Location *	WS
Category	Earthen Levee			GPS Latitude/Longitude	
				Start	End
Item	Encroachments			39.493423 °	39.493423 °
				-122.018885 °	-122.018885 °
DWR ID	DWR_LD0001G_01_s _ 2012_1				
Action/Comments					
Debris

View of the debris & garbage along the W/S toe.

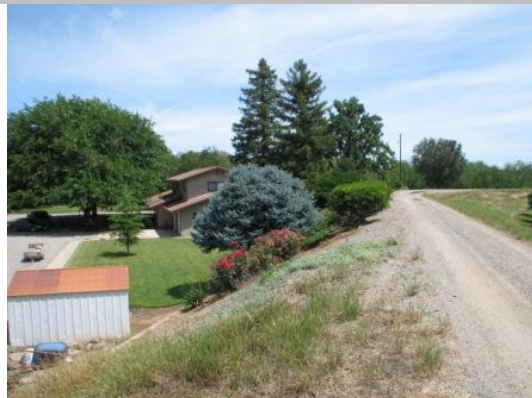
Photo 1 of 1 : FA\_2014\_LD0001G\_432\_6\_20141013\_00003.jpg

LM Start	1.35	Rating **	M	Issue No.	6
LM End	1.39	Issue Type +	En	Location *	LS
Category	Earthen Levee			GPS Latitude/Longitude	
				Start	End
Item	Vegetation			39.494828 °	39.495330 °
				-122.017632 °	-122.017163 °
DWR ID	DWR_LD0001G_01_s_2012_6				
Action/Comments					
Landscaping

View of the permitted landscape on the landside slope of the levee.

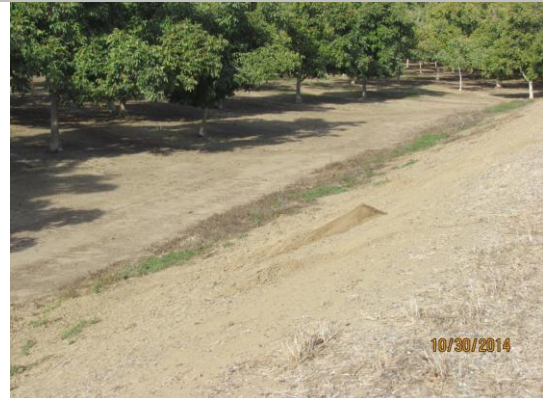
Photo 1 of 1 : FA\_2014\_LD0001G\_432\_51\_20141121\_00043.jpg

LM Start	3.15	Rating **	M	Issue No.	51
LM End	3.15	Issue Type +	Ma	Location *	N/A
Category	Earthen Levee			GPS Latitude/Longitude	
				Start	End
Item	Animal Control			39.513485 °	39.513485 °
				-122.009593 °	-122.009593 °
DWR ID	DWR_LD0001G_01_f_2014_51				
Action/Comments					
No rodents visible, but rodent burrows visible; need to backfill and compact or grout burrows.

View of the rodent activity along the landside slope.

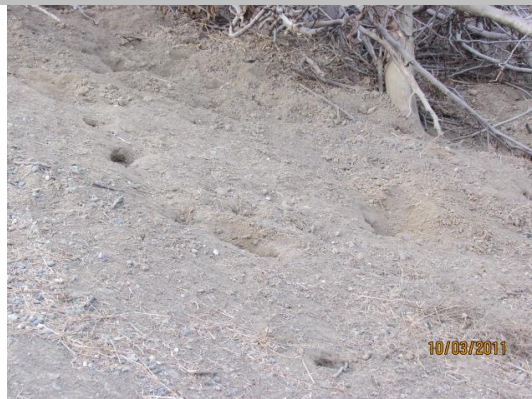
Photo 1 of 1 : FA\_2014\_LD0001G\_432\_395\_20141013\_00018.jpg

LM Start	3.94	Rating **	A/W	Issue No.	395
LM End	3.94	Issue Type +	Ma	Location *	LS
Category	Earthen Levee			GPS Latitude/Longitude	
				Start	End
Item	Animal Control			39.523845 °	39.523845 °
				-122.010745 °	-122.010745 °
DWR ID	DWR_LD0001G_01_s_2012_395				
Action/Comments					
No rodents visible, but rodent burrows visible; need to backfill and compact or grout burrows.

View of the rodent holes along the L/S toe.

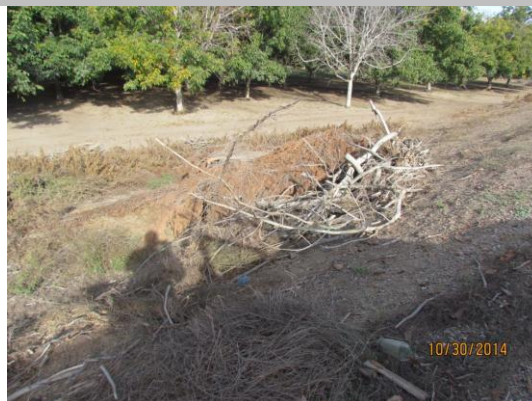
Photo 1 of 1 : FA\_2014\_LD0001G\_432\_52\_20141121\_00044.jpg

LM Start	3.94	Rating **	M	Issue No.	52
LM End	3.94	Issue Type +	Ma	Location *	LS
Category	Earthen Levee			GPS Latitude/Longitude	
				Start	End
Item	Encroachments			39.523855 °	39.523855 °
				-122.010762 °	-122.010762 °
DWR ID	DWR_LD0001G_01_f_2014_52				
Action/Comments					
Prunings

View of the prunings along the landside toe.

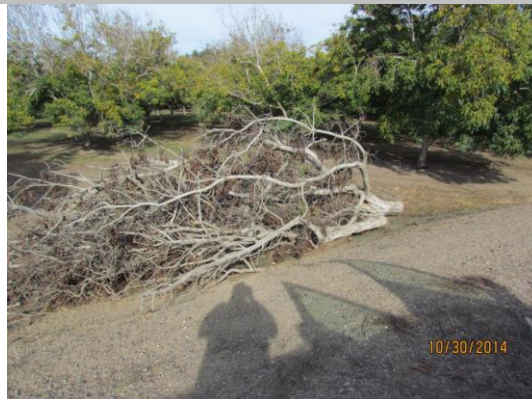
Photo 1 of 1 : FA\_2014\_LD0001G\_432\_53\_20141121\_00045.jpg

LM Start	3.99	Rating **	M	Issue No.	53
LM End	3.99	Issue Type +	En	Location *	LS
Category	Earthen Levee			GPS Latitude/Longitude	
				Start	End
Item	Encroachments			39.524432 °	39.524432 °
				-122.010417 °	-122.010417 °
DWR ID	DWR_LD0001G_01_f_2014_53				
Action/Comments					
Prunings

View of the prunings along the landside toe.

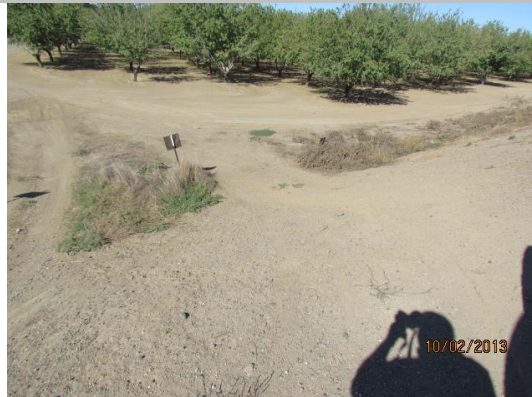
Photo 1 of 1 : FA\_2014\_LD0001G\_432\_57\_20141013\_00017.jpg

LM Start	5.14	Rating **	M	Issue No.	57
LM End	5.14	Issue Type +	Ma	Location *	LS
Category	Earthen Levee			GPS Latitude/Longitude	
				Start	End
Item	Slope Stability			39.534593 °	39.534593 °
				-121.995950 °	-121.995950 °
DWR ID	DWR_LD0001G_01_f_2013_57				
Action/Comments					
Repair the levee slope damaged by vehicle traffic and prevent access where possible.

View of the vehicle erosion along the slope of the levee.

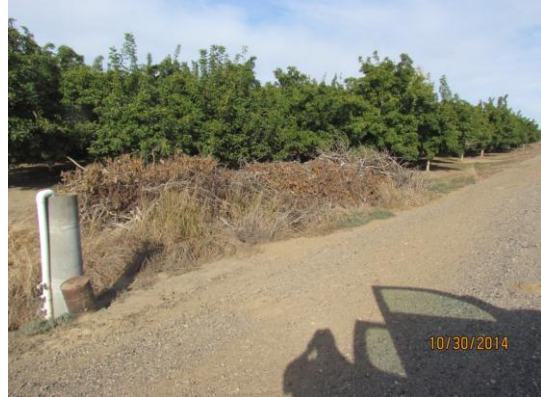
Photo 1 of 1 : FA\_2014\_LD0001G\_432\_54\_20141121\_00046.jpg

LM Start	5.99	Rating **	M	Issue No.	54
LM End	5.99	Issue Type +	En	Location *	LS
Category	Earthen Levee			GPS Latitude/Longitude	
				Start	End
Item	Encroachments			39.545992 °	39.545992 °
				-122.001180 °	-122.001180 °
DWR ID	DWR_LD0001G_01_f_2014_54				
Action/Comments					
Prunings

View of the prunings along the landside toe.

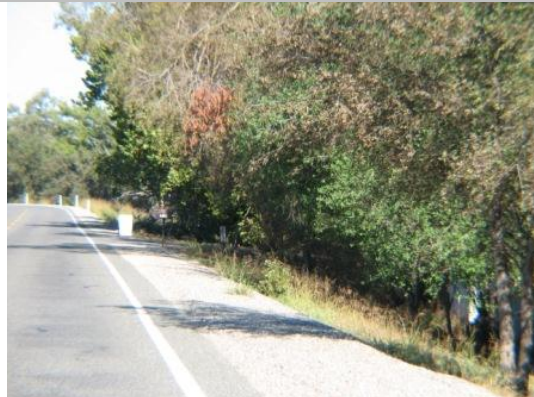
Photo 1 of 1 : FA\_2014\_LD0001G\_432\_20\_20141013\_00010.jpg

LM Start	8.17	Rating **	M	Issue No.	20
LM End	8.28	Issue Type +	Ma	Location *	WS
Category	Earthen Levee			GPS Latitude/Longitude	
				Start	End
Item	Trim / Thin Trees			39.576580 °	39.578187 °
				-122.004962 °	-122.005218 °
DWR ID	DWR_LD0001G_01_s_2012_20				
Action/Comments					
Thin trees to allow visibility of the ground and room to flood fight.

View of the trees and vegetation along the waterside slope of the levee.

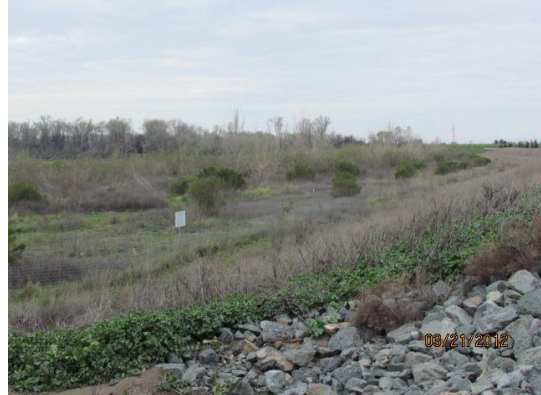
Photo 1 of 1 : FA\_2014\_LD0001G\_432\_8\_20141013\_00005.jpg

LM Start	9.69	Rating **	A/W	Issue No.	8
LM End	10.53	Issue Type +	Ma	Location *	WS
Category	Earthen Levee			GPS Latitude/Longitude	
				Start	End
Item	Vegetation			39.596192 °	39.607288 °
				-122.002573 °	-121.994565 °
DWR ID	DWR_LD0001G_01_s_2012_8				
Action/Comments					
Environmental Requirements.

View of the Army Corps of Engineers mitigation site.

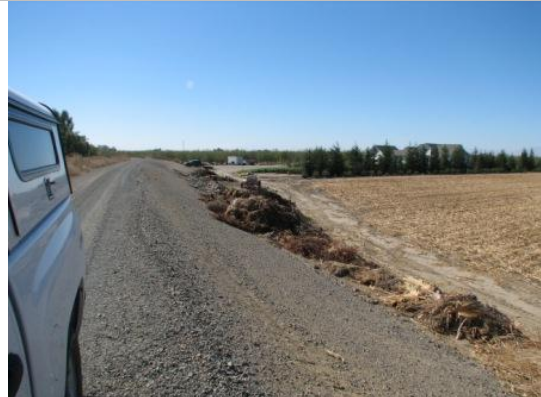
Photo 1 of 1 : FA\_2014\_LD0001G\_432\_11\_20141013\_00007.jpg

LM Start	9.70	Rating **	M	Issue No.	11
LM End	9.70	Issue Type +	Ma	Location *	LS
Category	Earthen Levee			GPS Latitude/Longitude	
				Start	End
Item	Encroachments			39.597078 °	39.597078 °
				-122.002127 °	-122.002127 °
DWR ID	DWR_LD0001G_01_s_2012_11				
Action/Comments					
Debris

View of debris along the toe of the levee.

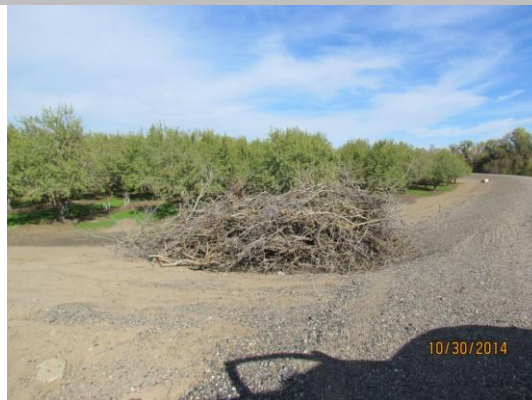
Photo 1 of 1 : FA\_2014\_LD0001G\_432\_55\_20141121\_00047.jpg

LM Start	10.57	Rating **	M	Issue No.	55
LM End	10.57	Issue Type +	En	Location *	LS
Category	Earthen Levee			GPS Latitude/Longitude	
				Start	End
Item	Encroachments			39.607705 °	39.607705 °
				-121.994267 °	-121.994267 °
DWR ID	DWR_LD0001G_01_f_2014_55				
Action/Comments					
Prunings

View of the prunings along the landside toe.

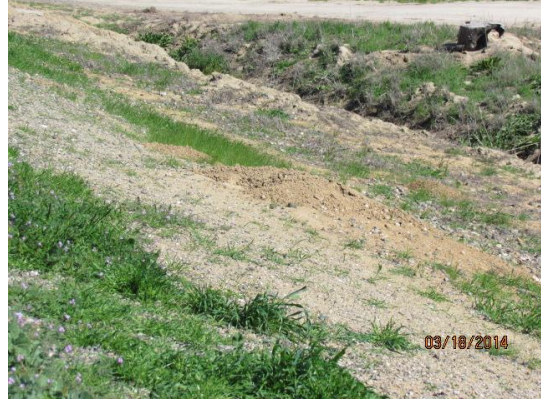
Photo 1 of 1 : FA\_2014\_LD0001G\_432\_48\_20141013\_00015.jpg

LM Start	11.70	Rating **	M	Issue No.	48
LM End	11.70	Issue Type +	Ma	Location *	WS
Category	Earthen Levee			GPS Latitude/Longitude	
				Start	End
Item	Animal Control			39.622652 °	39.622652 °
				-121.999185 °	-121.999185 °
DWR ID	DWR_LD0001G_01_s _ 2014_48				
Action/Comments					
No rodents visible, but rodent burrows visible; need to backfill and compact or grout burrows.

View of the rodent activity along the w/s slope.
